# Dedham Culvert & Bridge Asset Management

Prepared for: **Dedham DPW**  
55 River Street  
Dedham, MA 02026

Prepared by: **TEC, Inc.**  
146 Dascomb Road  
Andover, MA 01810

# Executive Summary

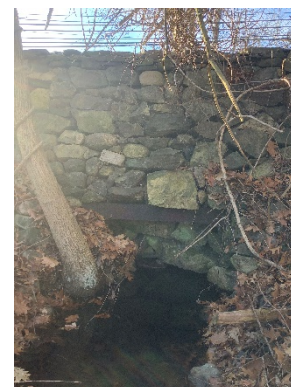
'Failing' Dry Laid Stone

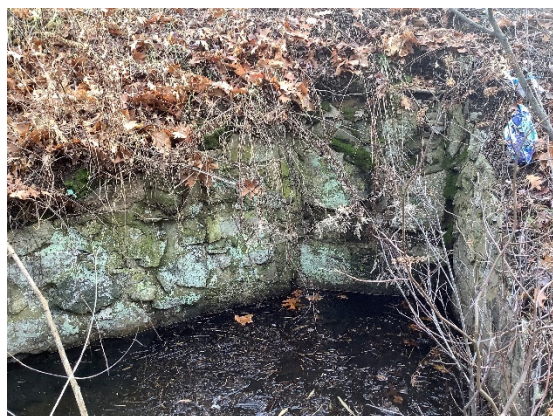
CUL-0006 carries Westfield Brook beneath High Street through what appeared to be a 40" wide dry laid stone culvert. The inlet side embankment was retained by a mortared stone headwall and wingwall combination, with the outlet side retained by a dry-laid stone retaining wall that spanned much further than just the crossing. The culvert itself was submerged and the outlet side was noted to have significant sediment buildup. According to Stream Stats, this crossing's drainage basin is approximately 0.1 square miles, and could see up to 16.5 CFS during a 10-year storm event.

Inlet (Fair): Culvert inlet was observed to be fully submerged during inspection. No obstructions or scour was felt while probing. Minor erosion was observed along embankment, with deteriorating mortar observed throughout head and wing walls. Wetland flagging was observed with ponding upstream.

Overhead wires are present near the culvert's outlet, and a wooden guardrail in satisfactory condition is present on both sides. As this crossing carries a high risk score and an outlet that has a large dry-laid stone retaining wall that was ranked as 'failing', TEC recommends the replacement of this culvert. The estimated remaining service life for this culvert is 5 to 10 years. TEC recommends a full culvert replacement with a three-sided box culvert. The estimated cost of replacement is \$700,000 to \$800,000, depending on the results of the field survey, hydraulic study, and geotechnical investigations.

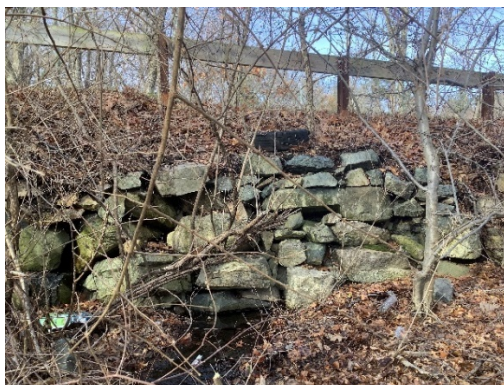
Outlet (Failing): The culvert invert was observed to be significantly lower than sediment surrounding it. The stone headwall had voids and sections of stones missing throughout, with soil washout observed between voids.

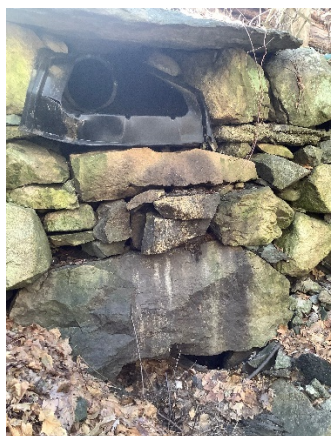
CUL-0007 is located adjacent to 149 Village Avenue and consists of dry-laid stone headwalls on both sides to hold back approximately 10 feet of cover over a dry-laid stone culvert which is 90% obstructed by sediment. While the location dictates a relatively low risk to the town should failure occur, the lack of flow opening combined with the amount of soil retained by dry-laid headwalls in poor condition with stormwater discharges above them creates a higher risk of embankment failure affecting the roadway above it.

The culvert is almost completely filled with sediment, preventing general flow. Voids were observed throughout headwall, with sections of loose stones. Above the headwall is a 12" HPDE drainage outfall which leads to the catch basin approximately seven feet above it. Upgradient is closely abutted by a house.

Overhead wires, water line (hydrant), and drainage is present on the roadway. Wooden fencing is present on both sides. The estimated remaining service life for this culvert is 5 to 10 years. TEC recommends a full replacement with a three or four sided concrete box culvert. The estimated cost of replacement is \$900,000 to \$1,000,000, with costs depending on the results of a field survey, hydraulic study, and geotechnical investigations

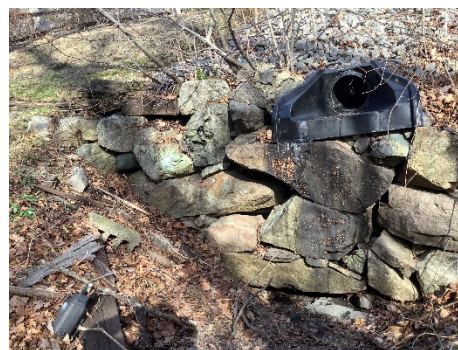
The culvert is almost completely filled with sediment, preventing general flow. Embankment consists of slope down to dry laid stone headwall. Voids observed throughout headwall. 12" HDPE drainage outfall at top of headwall. Small irrigation line placed directly above crossing. Fallen trees present downgradient. Erosion observed on the right side of headwall.

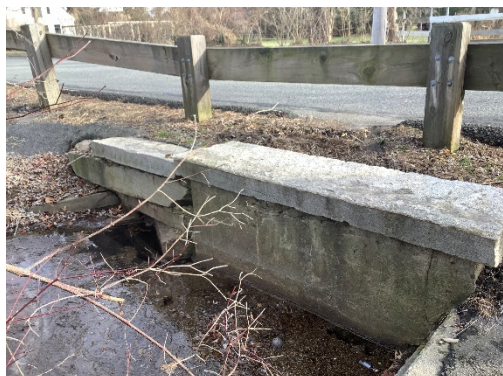
CUL-0010 is located along Highland Street and carries Lowder Brook through a 24 inch box culvert. The inlet was in poor condition, and based on field observations, abutter anecdotal comments, and the presence of CUL-0011 as an overflow, CUL-0010 appears to be undersized. This is rebuffed with Stream Stats determination of almost 1.5 square miles of watershed area contributing to a peak flow of 119 CFS during the 10-year storm event.

Inlet (Poor): Chipping, spalling, and general deterioration was observed throughout the headwall, with the section of granite blocks severely shifted. The embankment was generally stabilized with asphalt, with the exception of above the headwall where evidence of sheet flow was observed. The culvert wasn't able to be visually inspected as it was fully submerged, however no obstructions or scour was felt while probing.

Overhead wires and the previously mentioned drainage were the only utilities observed, with substandard traffic safety features present. This, combined with the relatively small bankfull widths (10 and 14 ft) coupled with low roadway cover over the culvert lends this crossing to be a good candidate for a precast box culvert replacement to prevent roadway overtopping and abutter flooding during large storm events. The estimated remaining service life for this culvert is 5 to 10 years. It is TEC's recommendation to fully replace the existing culvert with a three-sided concrete box culvert. The estimated cost of replacement is \$600,000 to \$700,000 depending on the results of the field survey, hydraulic study, and geotechnical investigations.

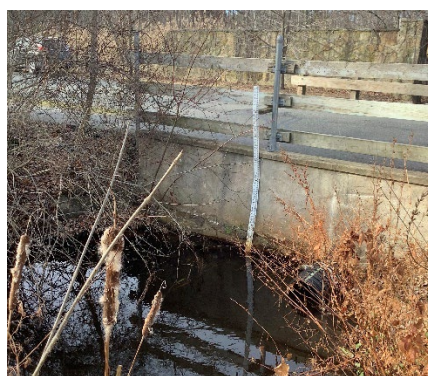
Outlet (Fair): Minor cracking and chipping of the headwall, with areas of minor erosion along the embankment was observed.

Adjacent to the outlet, a 12" HDPE Pipe assumingly tied into the roadway catch basin was observed to also outlet. While the interior of the culvert wasn't able to be visually inspected due to high water, no obstructions or scour was felt during probing.

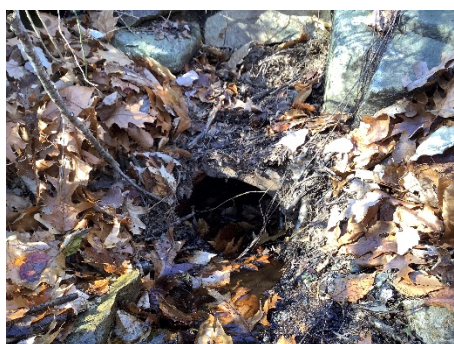
The crossing is located at 294 Westfield Street and carries Weld Stream through a 15 inch VCP culvert. The inlet and outlet conditions were both poor, as the culvert and dry-laid headwalls were deteriorating. According to StreamStats, this crossing carries the overflow of Weld Pond on it's way to the Charles River, and can see upwards of 10 CFS during the 10-year design storm. The crossing is also upgradient of CUL-0004. Westfield Street is a dead end and failure of this crossing during large storm events would result in restricted access, as well as potential upstream flooding as both inlet and outlet have approximately 5 feet of cover between roadway elevation and top of pipe.

Inlet (Poor): The inlet of the pipe was partially buried, and leaves had to be cleared around the opening. The VCP was noted to be cracked, with sediment within it. The dry-laid headwall was in poor condition, with multiple voids and missing stones observed in the headwall.

Reflectors were observe at both the inlet and outlet, with only overhead wires with utility poles observed for utilities. The estimated remaining service life for this culvert is less than 5 years. It is TEC's recommendation to complete a full replacement with a four-sided concrete box culvert. The estimated cost of a full replacement is \$400,000 to \$500,000 depending on the results of the field survey, hydraulic study, and geotechnical investigations.

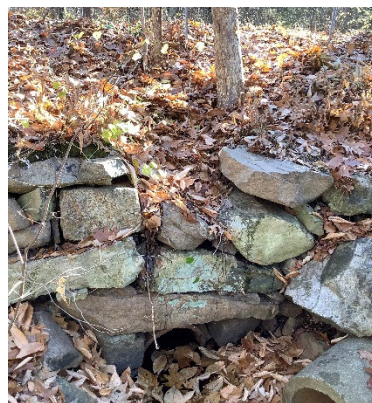
Outlet (Poor): The outlet of the pipe was observed to be cracking along the top of the pipe, with leaves and rocks obstructing the opening. The dry-laid headwall observed to be in poor condition, and a 12 inch RCP drainage outfall was noted to be protruding through the right side of the headwall.

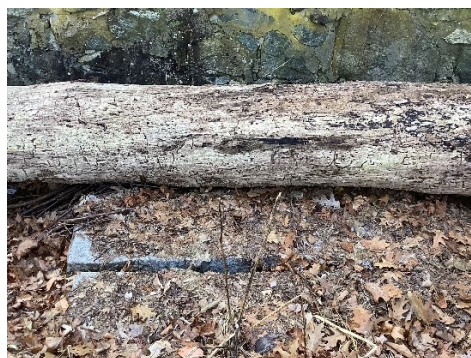
CUL-1005 is located at 265 Common Street, just south of the Dedham Parks and Recreation Complex. The crossing consists of a dry-laid inlet south of the roadway to an 18-inch RCP outlet north of the roadway. The crossing is a direct tributary to the Charles River which is just north of the crossing. Immediately upstream of the inlet is an approximately 6-foot mortared stone wall with an assumed culvert under it feeding CUL-1005. The inlet was noted to be in poor condition with multiple large granite stones covering the top of the inlet spanning between the inlet and the stone wall. The outlet was noted to be in fair condition with scaling and standing water observed within the pipe.

Inlet (Poor): The inlet is located between an assumed culvert that runs under a privately owned mortared stone wall and the roadway. The inlet was observed to be at a low point of a roadway swale, and covered by partially buried granite blocks and a log preventing a full inspection of both the inlet and the assumed private culvert outlet. A dry-laid stone headwall was observed to be in fair condition around the inlet.

No traffic safety features were observed, however overhead wires, a sewer manhole, and a fire hydrant were all present along the roadway. The estimated remaining service life for this culvert is 5-10 years, with immediate maintenance potentially extending the service life. Estimated cost of replacement with 3 sided box culvert is \$550,000 to \$650,000.

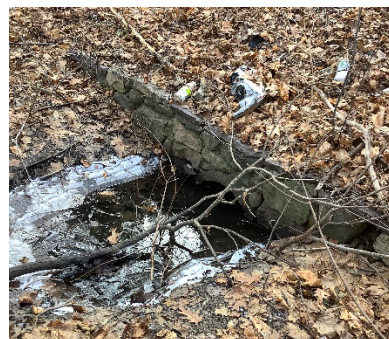
Outlet (Fair): The outlet is comprised of an 18 RCP with approximately 9 inches of standing water observed at the outfall. Scaling was observed within the pipe, and it was approximately 25% obstructed by leaves. The mortared stone headwall was observed to be in satisfactory condition, and the embankment in fair condition with trees, and general trash observed.
