**-- COLBURN STREET DAM --**

**INSPECTION / EVALUATION REPORT**

Dam Name: Colburn Street Dam  
State Dam ID#: 6-11-73-2  
NID ID#: MA02571  
Owner: Department of Conservation and Recreation  
Owner Type: Commonwealth of Massachusetts  
Town: Dedham  
Consultant: Weston & Sampson  
Date of Inspection: May 23, 2006

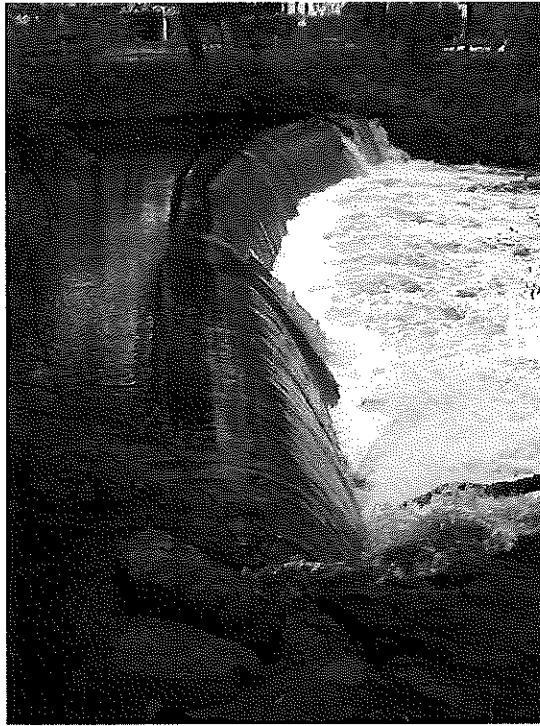
The spillway could not be thoroughly observed due to high flow conditions. However, the vertical and horizontal alignment and condition of flow over the spillway suggests the structure is in sound stable condition. We observed a depression in the stone masonry weir approximately 20 ft. from the right abutment. It is possible that this is the notch or sluice gate opening mentioned above in Section 1.2.4. See photo 1.

We observed several moderate sized tree limbs caught in the flow over the weir. However, these did not appear to affect the flow. The shores of the brook are vegetated with brush and small trees. However, these do not appear to interfere with flow over the weir. The plunge pool immediately downstream of the spillway appeared to be clear of obstructions. See photo 1.

**Photo 1 - Colburn Street Dam from the right abutment. Note bedrock abutments, debris on weir, notch or sluice in weir at location of darkened flow.**

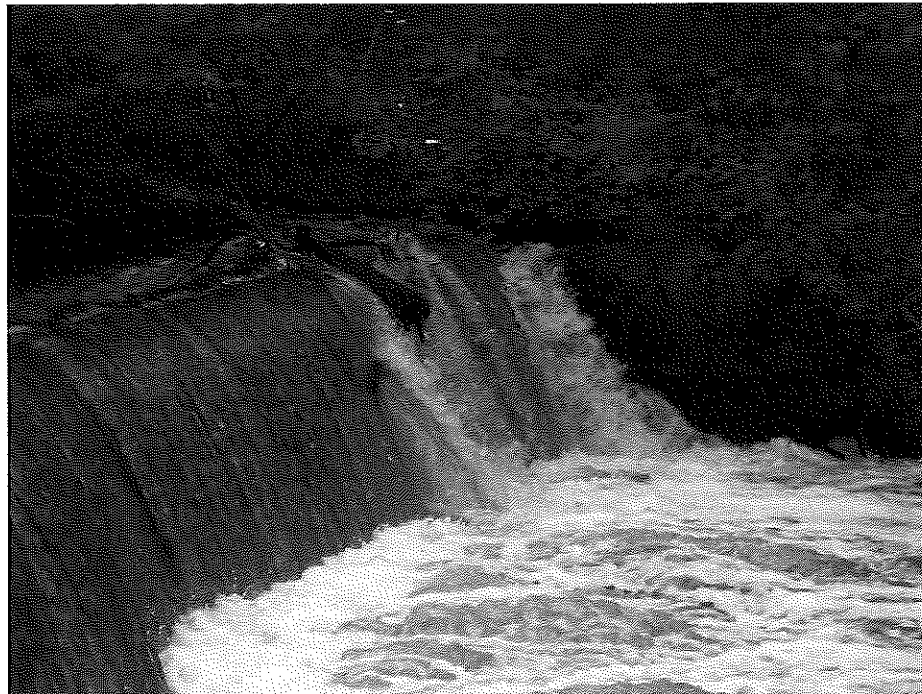
**Photo 2 - Left abutment of the dam. Note bedrock abutment and debris.**

- Woody vegetation on the abutments should be cut to ground surface, then a healthy stand of grass should be developed on those areas and maintained in that condition.

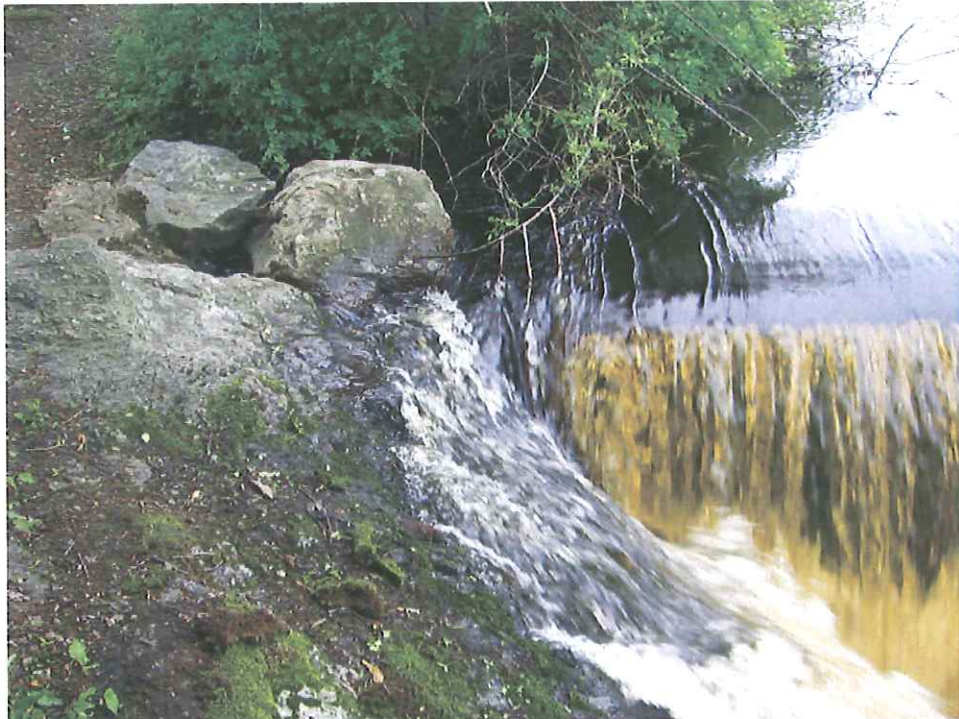
Photo 3 - Right abutment looking upstream. Bedrock abutment at high flow.
