-- COLBURN STREET DAM --
PHASE I
INSPECTION / EVALUATION REPORT

Dam Name: Colburn Street Dam
NID ID#: MA02571
Owner: Town of Dedham, MA
Town: Dedham
Consultant: GEI Consultants, Inc.
Date of Inspection: January 26, 2018

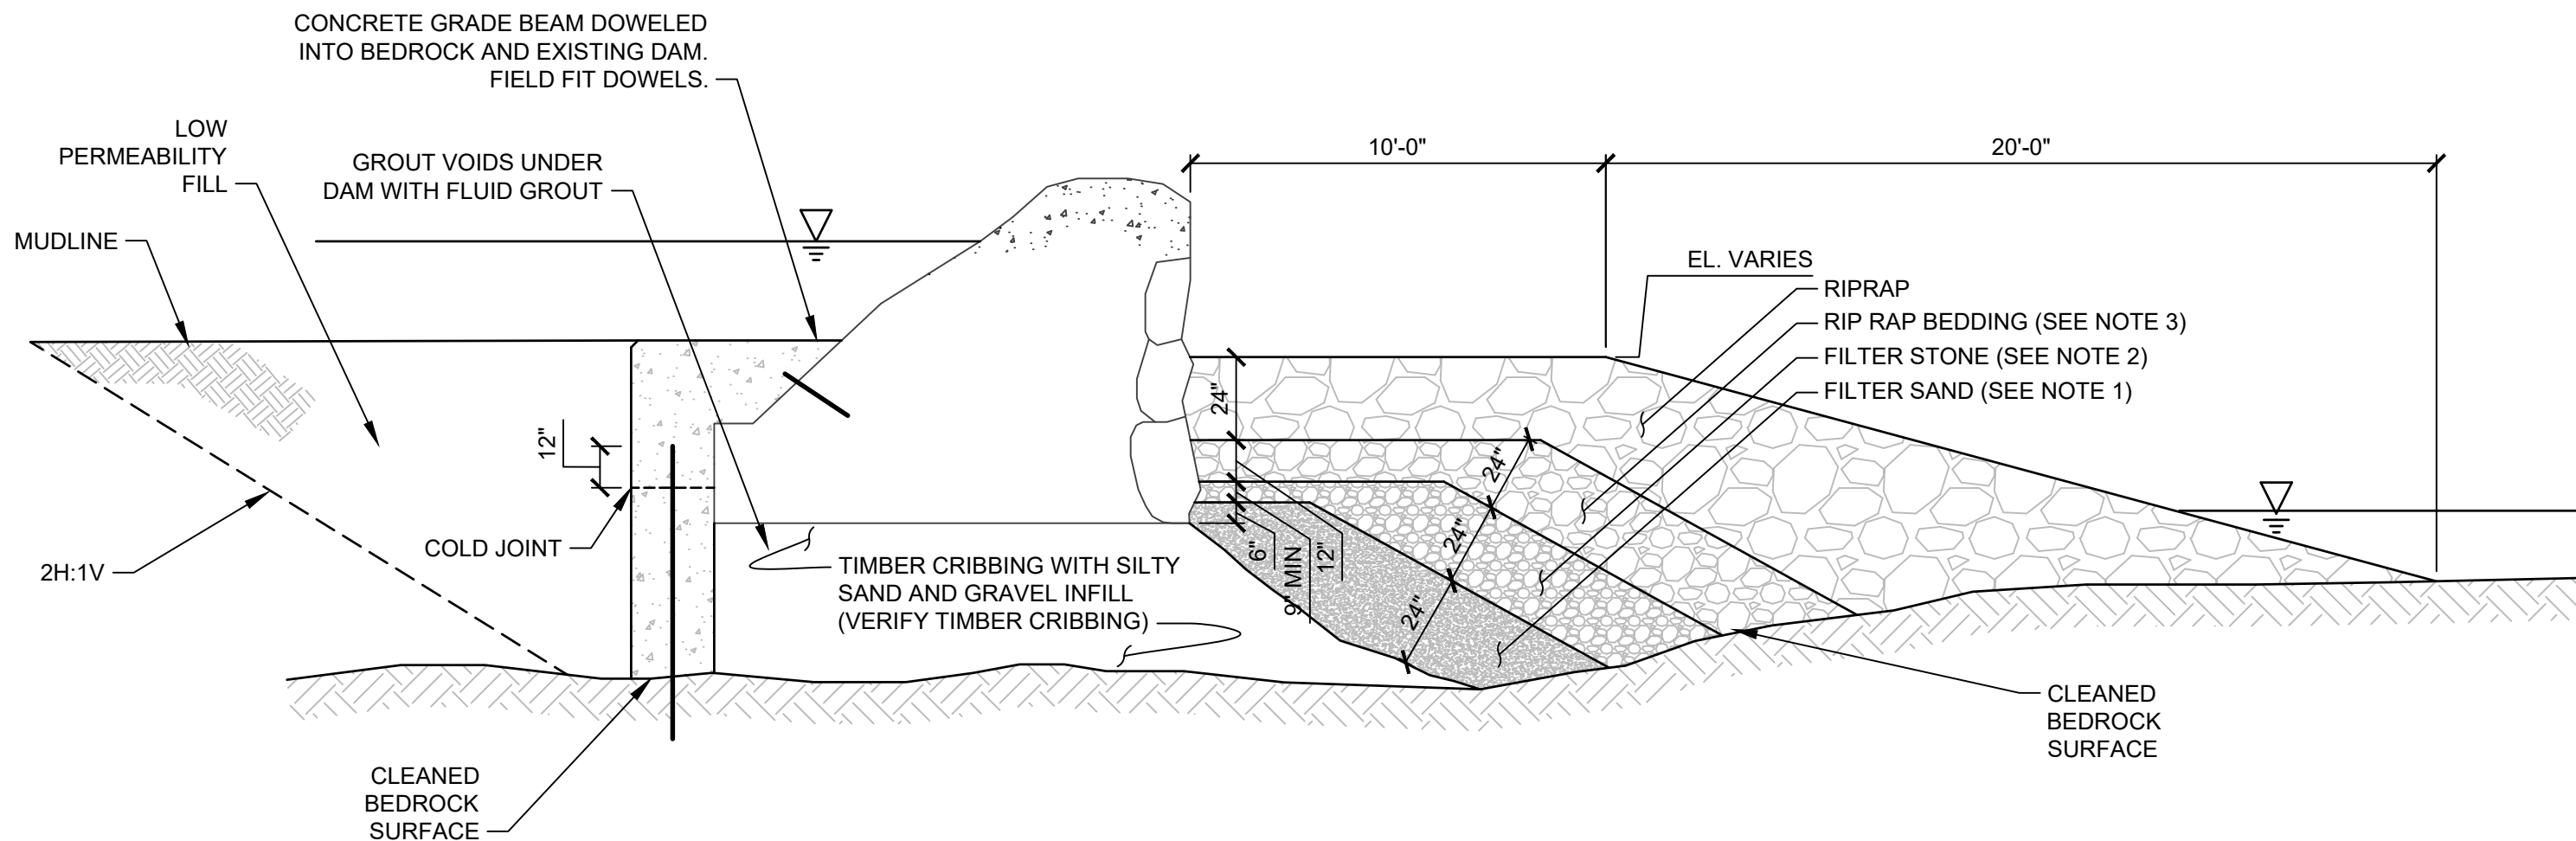
As part of the rehabilitation work, a graded filter was installed on the downstream side of the dam adjacent to the foundation soil (Figure 5). Dewberry observed the installation of the graded filter during construction.

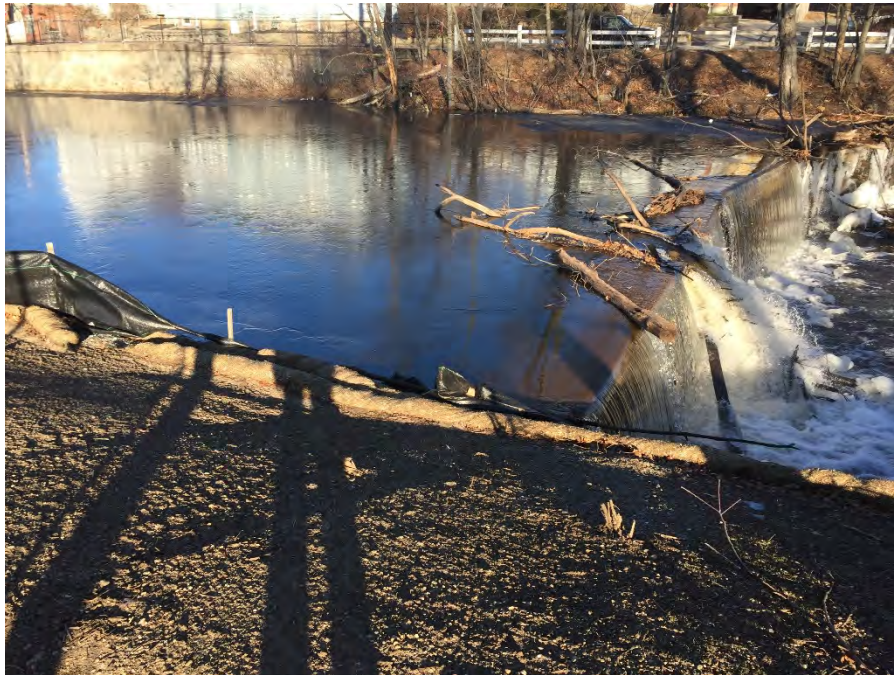
Both abutments were in satisfactory condition. The grass on the right bank is being reestablished following the rehabilitation project, which mainly accessed the site from this side. There is some vegetation and small trees along the right abutment. See photos 1 and 16.

Photo No. 1 – Dam and impoundment viewed from right abutment.

1. Regular maintenance activities should be performed to control growth of unwanted vegetation on the abutments and remove accumulated debris at the spillway. Grass cover should be maintained on the abutment slopes.
2. Perform an inspection of the dam during the annual brush clearing to observe and document dam conditions.

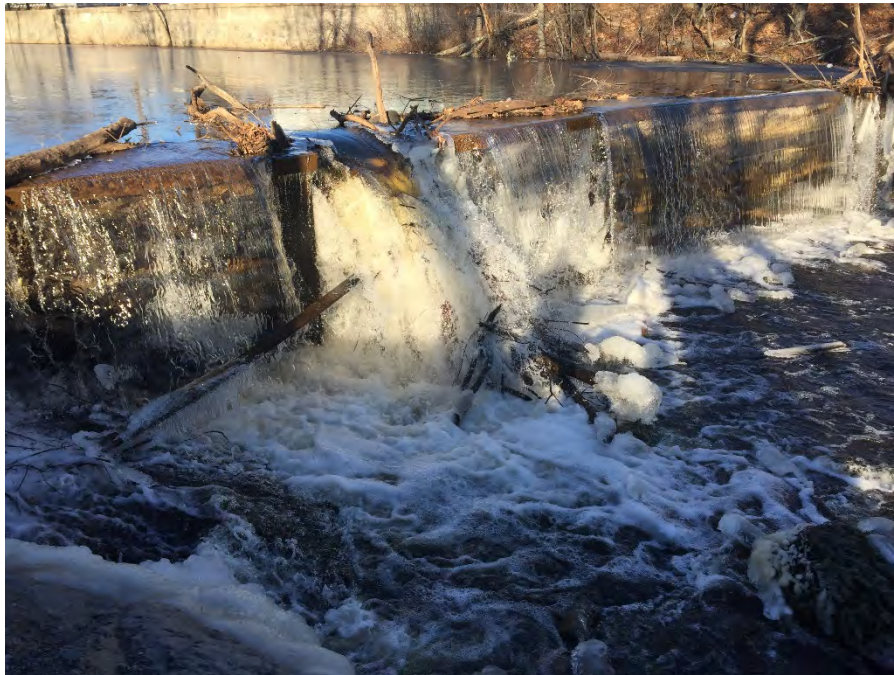
The downstream face was partially visible through the flow going over the crest. The stone masonry was in good alignment, with no evidence of leakage or seepage (Photos 3 and 17). The mortar visible between the stones appeared to be in good condition.

Photo No. 3 – Downstream face and notch (sluiceway).

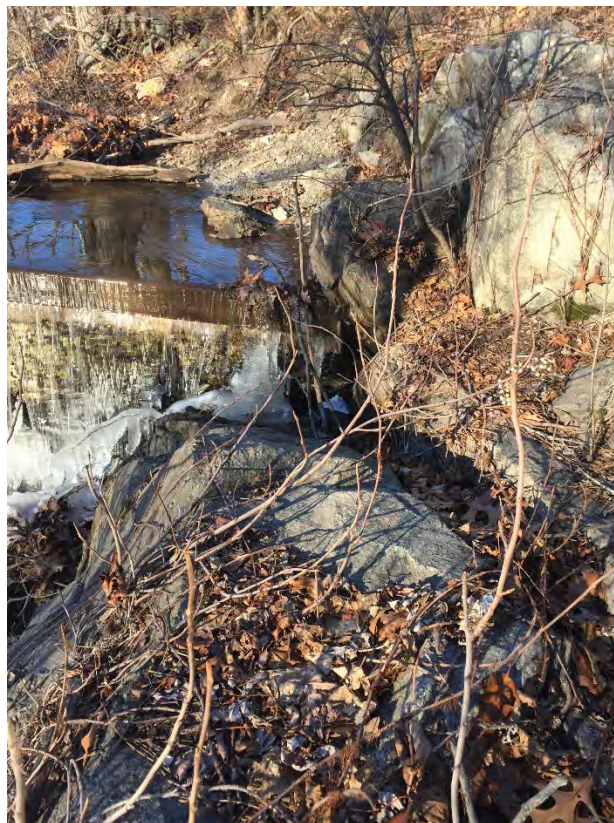
Photo No. 16 – Left abutment interface with bedrock. Note small brush.

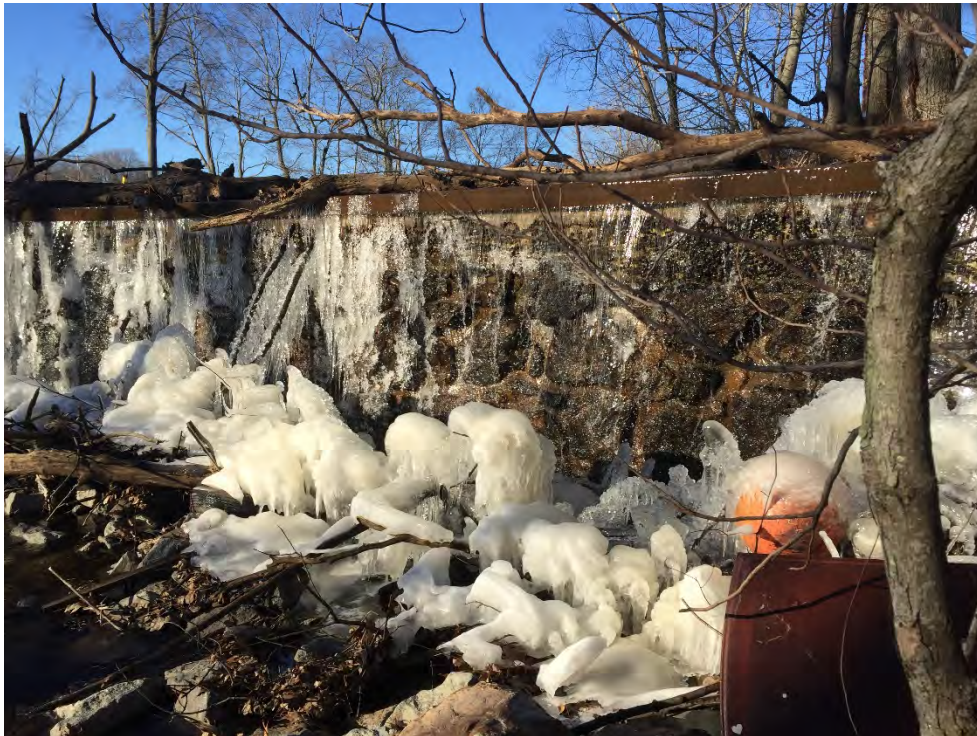
Photo No. 17 – Downstream face view from left downstream toe.

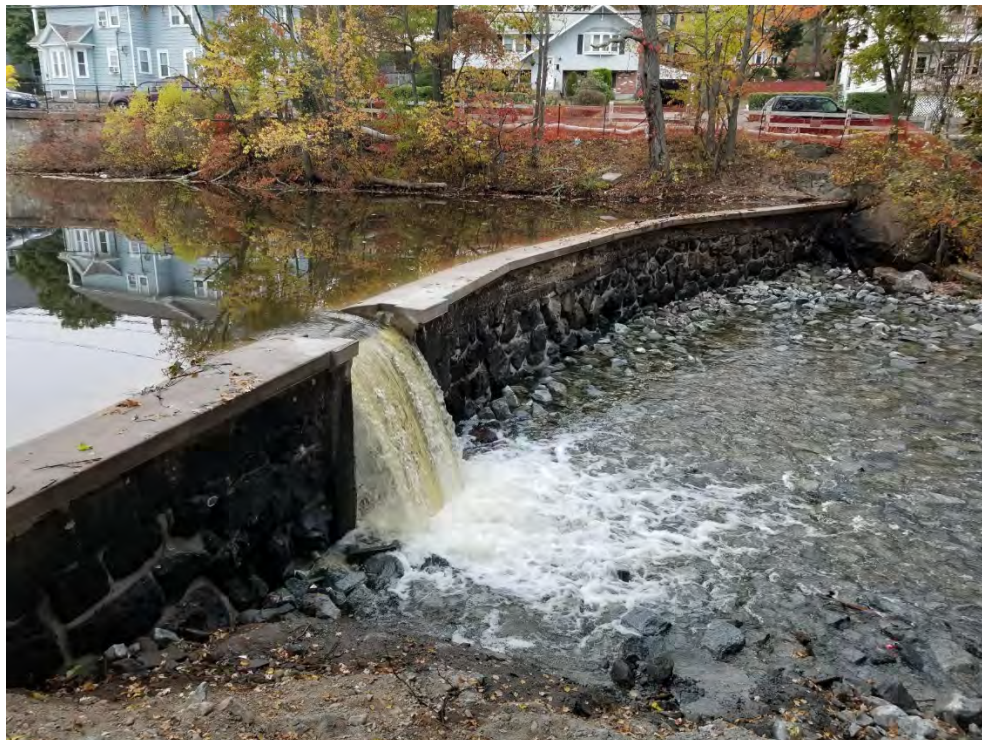
Following this assessment, the Town of Dedham performed a rehabilitation project to address these issues. The rehabilitation project consisted of repairs to the existing dam, including the application of pneumatically applied mortar to the upstream face, replacement of the existing stop logs, grouting and pointing the existing stone masonry, construction of a concrete cutoff, and installing a graded filter with riprap scour protection from the face of the dam downstream for approximately 30 feet. The rehabilitation project was completed in December 2017. The as-built drawings for the rehabilitation project are included in Appendix C. Figure 5 shows a schematic section through the dam, based on rehabilitation design. Photo 20 in Appendix A shows the stop log sluiceway.

Photo No. 20 – Photo taken in November 2017 at the completion of rehabilitation construction.
