2018 Sewer Manhole Investigation FINAL - Report

Town of Dedham, Massachusetts Weston & Sampson Project No. 2180144

Re: Final Report – 2018 Sewer Manhole Investigation

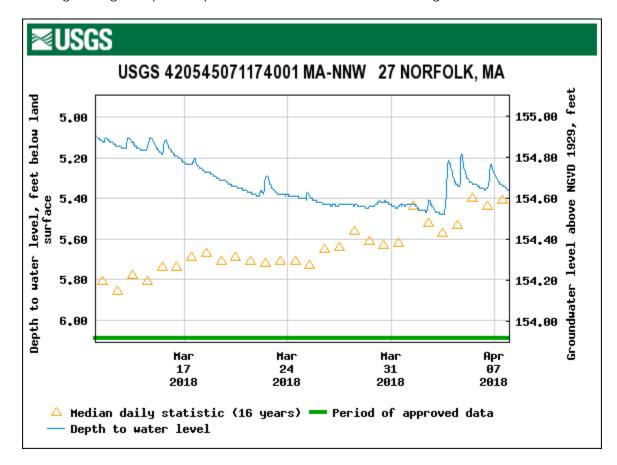
According to the USGS groundwater gauge located in Norfolk, Massachusetts, groundwater levels during the 2018 Sewer Manhole Inspections (March 12 to April 6, 2018) were above the average springtime elevations. The springtime groundwater levels provide an optimal period to conduct investigations because during this time, the potential for infiltration is at its highest. Please note that the groundwater gauge site is located outside of Dedham and only serves to indicate regional groundwater elevation trends. This data is not a direct indication of the immediate study area. The following figure shows actual groundwater elevations, measured continuously, over the last year. This includes the time period in which the manholes inspections were performed. The blue line indicates actual measurements

and the orange triangles represent percentile classes of historical averages.
